Relationship between reliability centered maintenance and condition monitoring (Case study)

In this paper, the effective role of and the relationship between reliability centered maintenance (RCM) and condition monitoring (CM) techniques (vibration analysis, sound, and oil and failure analysis) are considered in one of the vital petrochemical equipment. Given the critical role of MX-840 extruder in the production of the Tabriz Petrochemical Complex, the machine is a critical machine with a degree A and a sensitivity score of 92 to 100. As a result, the RCM method was applied to the machine and was under the care and condition monitoring. By observing the increase in sound and the first failure symptoms, the weekly monitoring of the equipment was placed on the CM unit agenda. By examining the trend of increasing the wearing index in the oil analysis results, the increase of HDm (High Definition Technology) in the data acquisitions of Shock Pulse technology and also the observation of the failure frequency of one of the gears with the mid-shaft harmonics, the CM department reported an increase in the clearance of the bearings and the beginning of failure. After the technical meeting

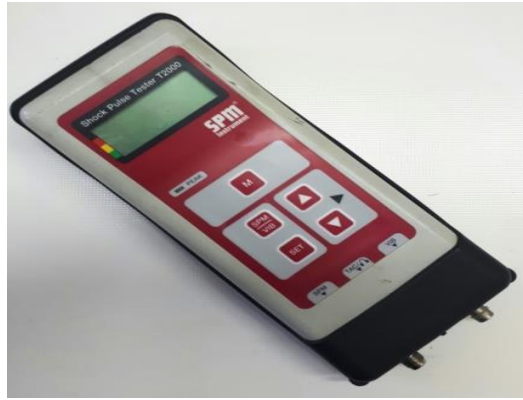
Figure2. T2000 Machine

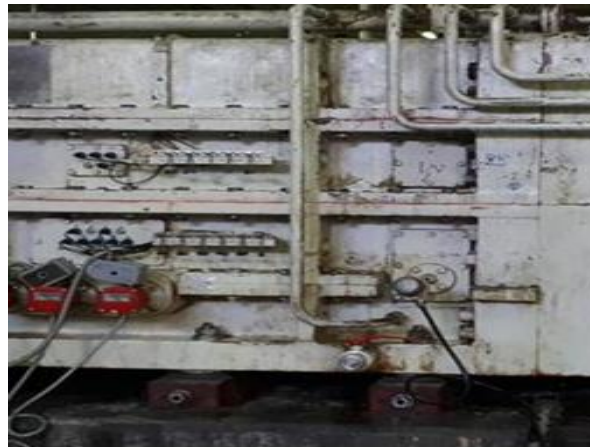
Figure3. Termination Box

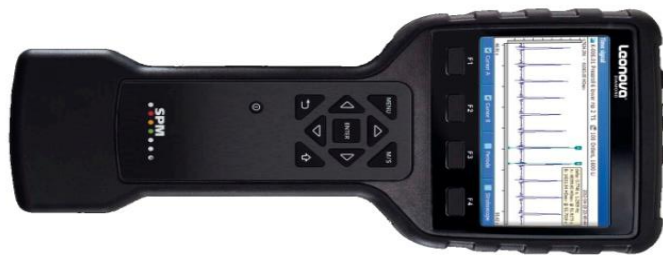
Given the fact that the T2000 did not have the capability of spectrum analysis and time waveform, the CM unit commissioned the purchase of the new Leonova Diamond model (figure5), which SPM Co. added the Spectrum function, time waveform, balance, etc., based on the above calculations and defined the HDm index for the newer model so that the user can control the state of the bearings easily and without the need for calculations, and only by examining the process changes and the energy range of shock pulses (Condmaster, 2016 and (Brunner and Ganga-Contreras, 2017).

Figure 5. New Leonova Diamond model

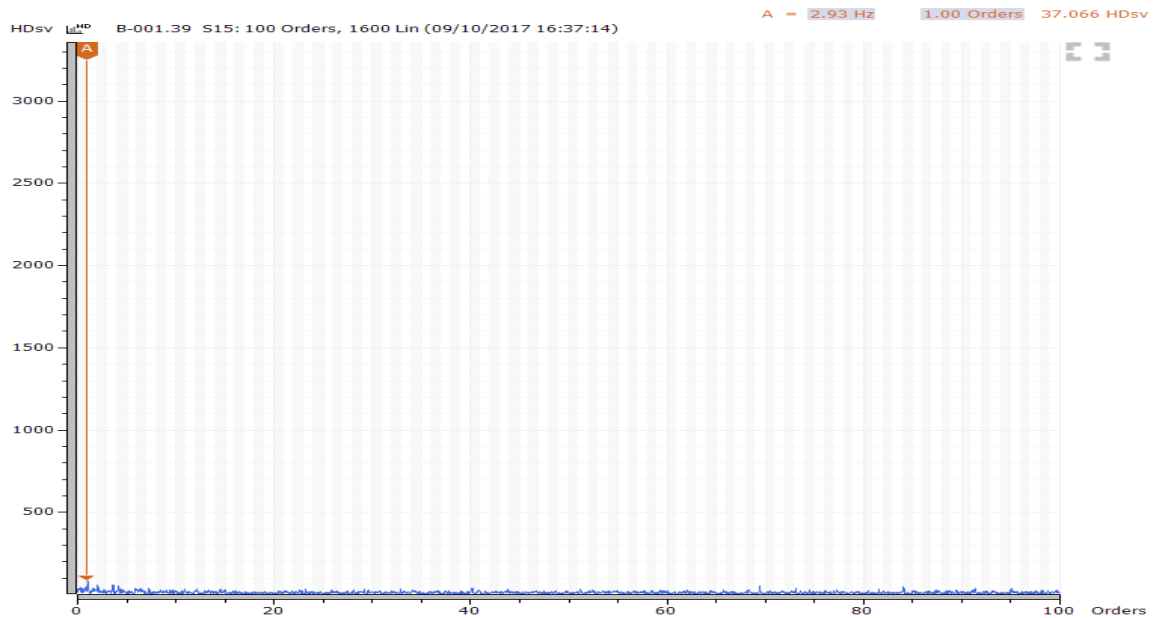
Figure 8. Spectrum of shock pulse of sensor 15 - after repairs

As shown in Figures 7, 8, 9, and 10, after the repairs and with the bearing replacement, all specifications related to the failure frequencies have been reduced, and the shock pulse energy has also reached the normal range. Bearing damaged evidence on roller bearings and outer ring is evident in the figure 11.

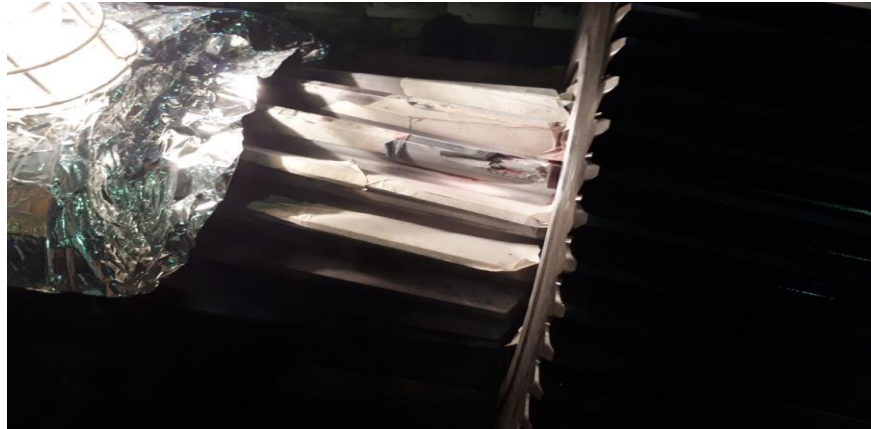
Defected Gear. As in the figures 18 and 19, it is clear that fracturing is part of a gear 500 and the other gears are impacted by the inappropriate involvement of the shaft 500 with the shaft facing.

Figure 19. Defected teeth of Gear

As the comparison of Figures 13 and 17 together and Figures 14 and 16 show that the damping frequencies associated with the Gear Mesh are still evident due to the damaged gear being not replaced and merely being rolled up to remove the crack.
